# Mount Pearl Trails Accessibility Guide

Accessibility Guide developed in partnership with

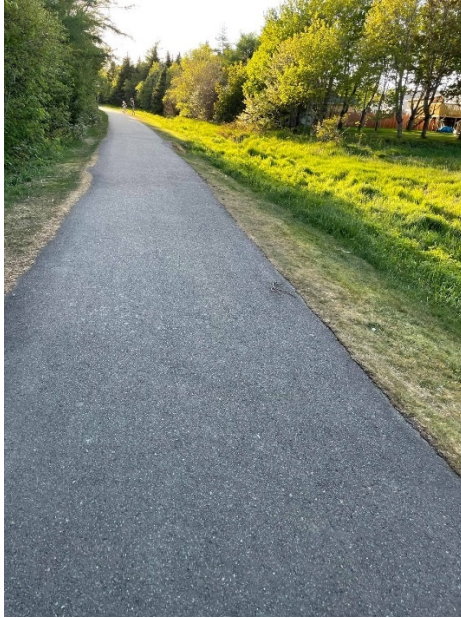
Figure 3: Caution near river, ponds, ditches – edge protection not present

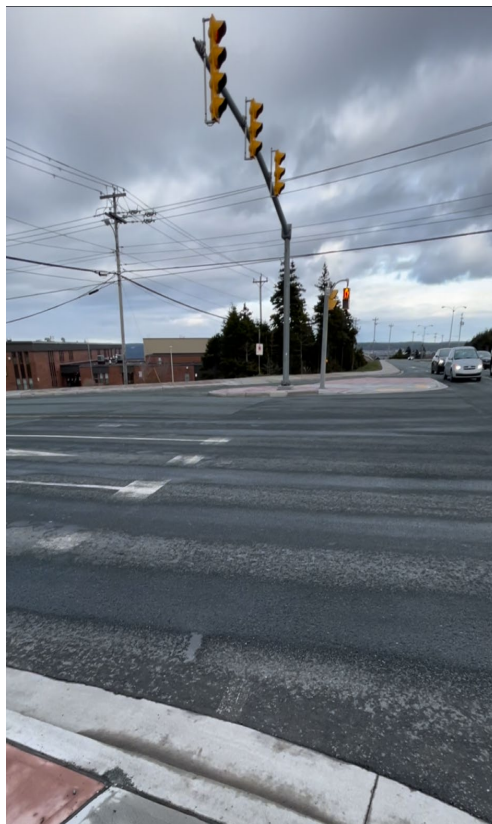
Figure 4: No auditory signals available at crosswalk

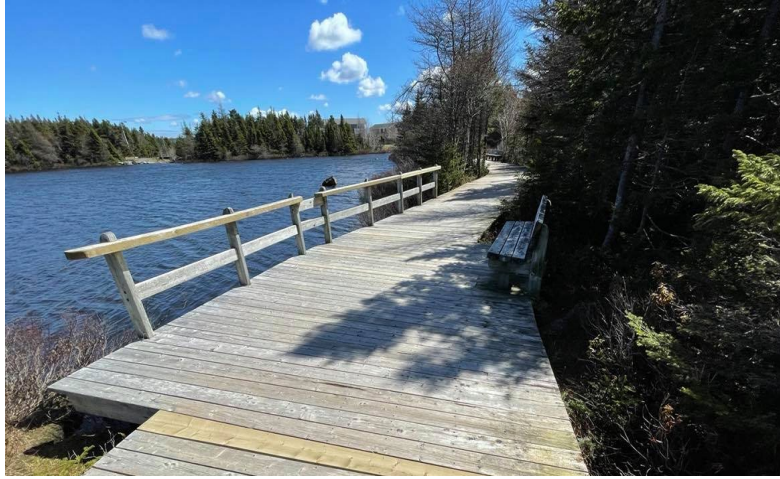
Figure 7: Edge protection not present -  
Handrails available near river's edge

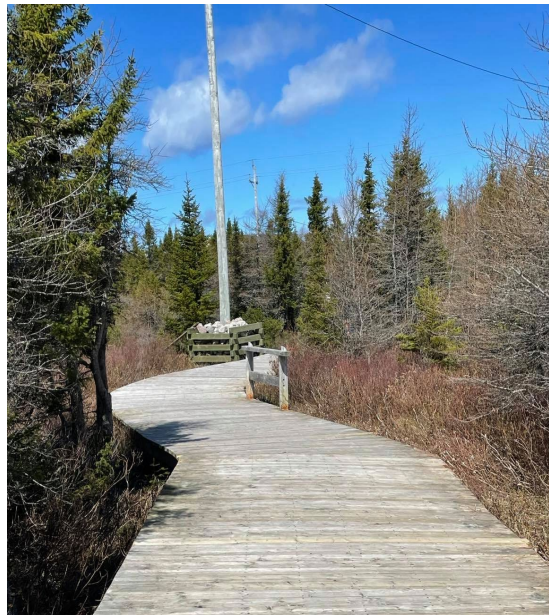
Figure 8: Boardwalk curves  
No edge protection present

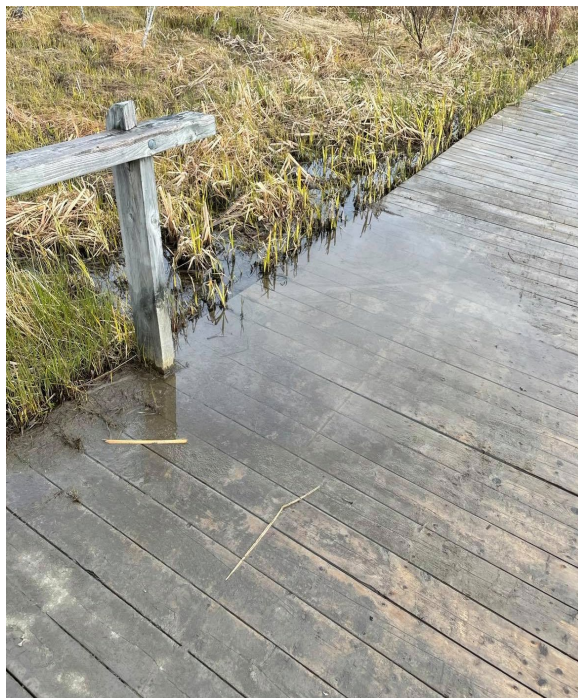
Figure 9: Boardwalk flooded in spots

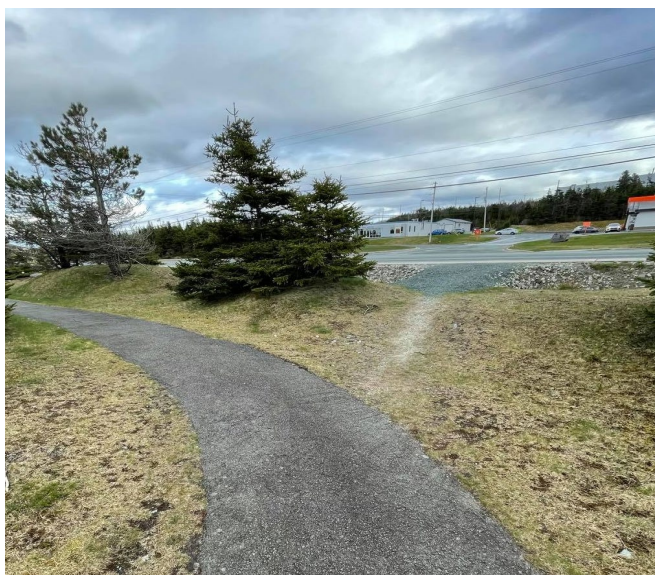
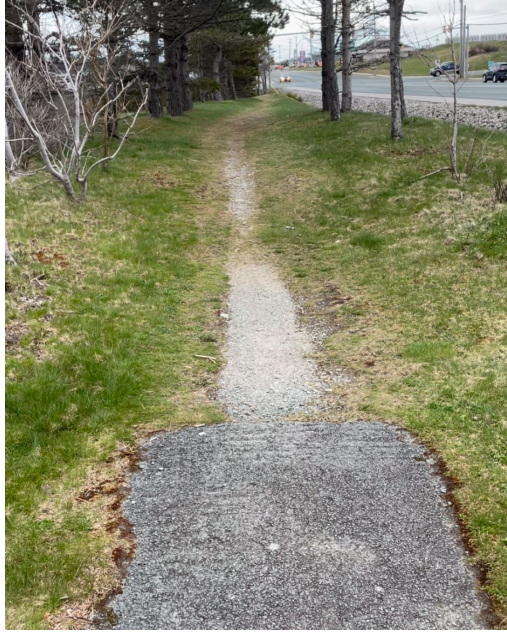
Figure 10: Asphalt trail leaving Power's Pond area near Old Placentia Road ends abruptly with no accessible route off trail

Figure 11: Asphalt trail leaving Power's Pond area near Old Placentia Road ends abruptly with no accessible route off trail

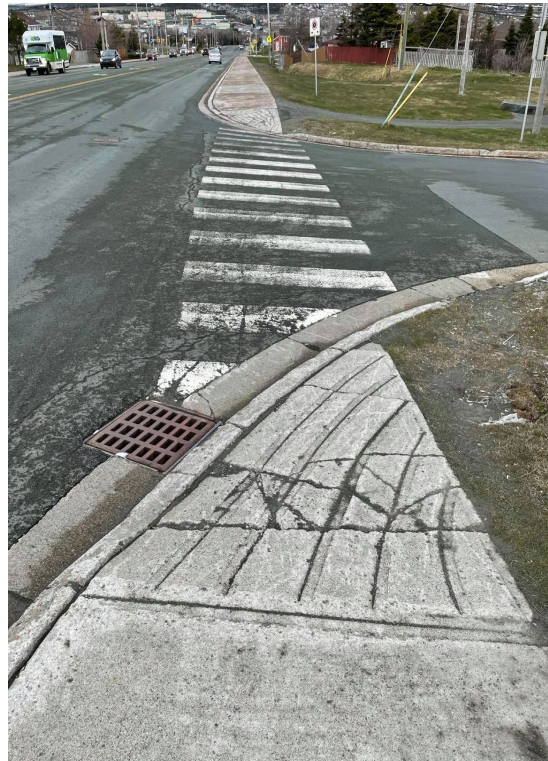
- Sidewalks and roads along Old Placentia Road and Ruth Avenue have many cracks and bumps. Tactile Attention Indicators (TAI) required(Figure 12)

Figure 12: Sidewalks and roads along Old Placentia Road and Ruth Avenue have many cracks and bumps. Requires Tactile Attention Indicator (TAI)

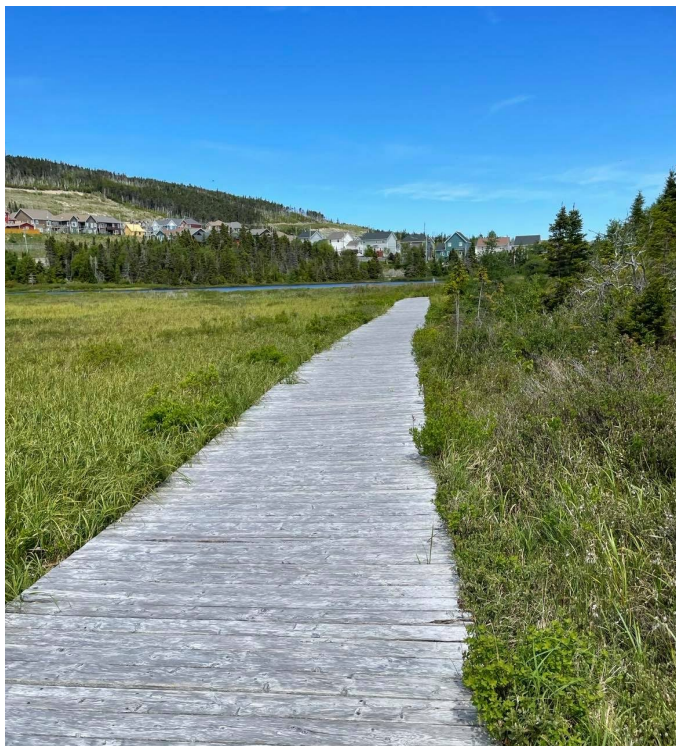
Figure 1: Boardwalk edge protection not present

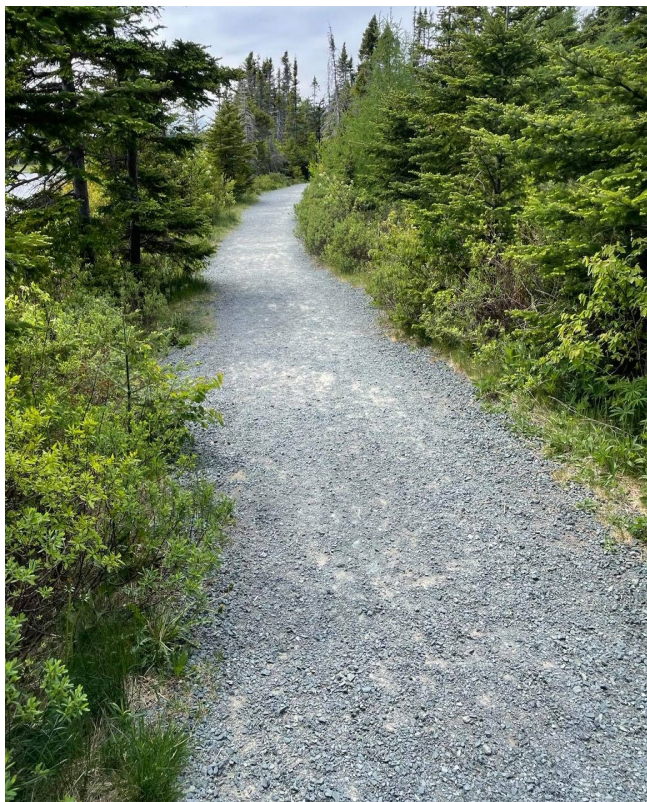
Figure 2: Loose gravel/crushed stone

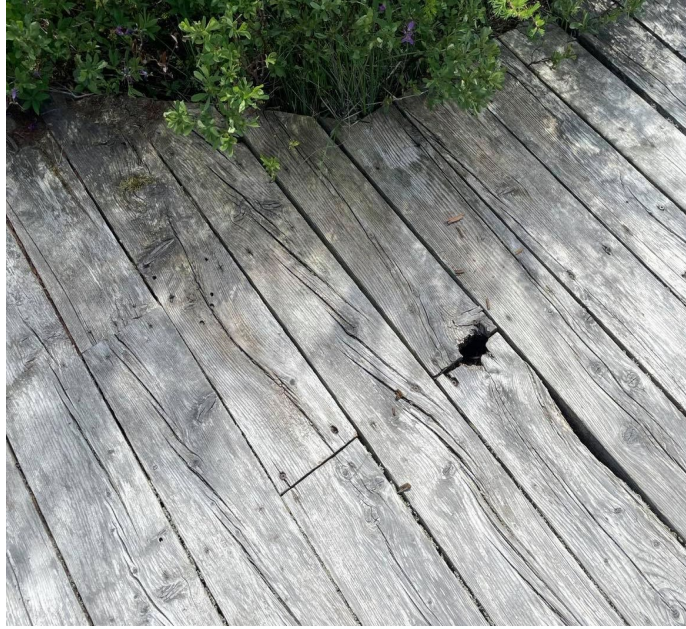
Figure 3: Broken and loose boards on boardwalk

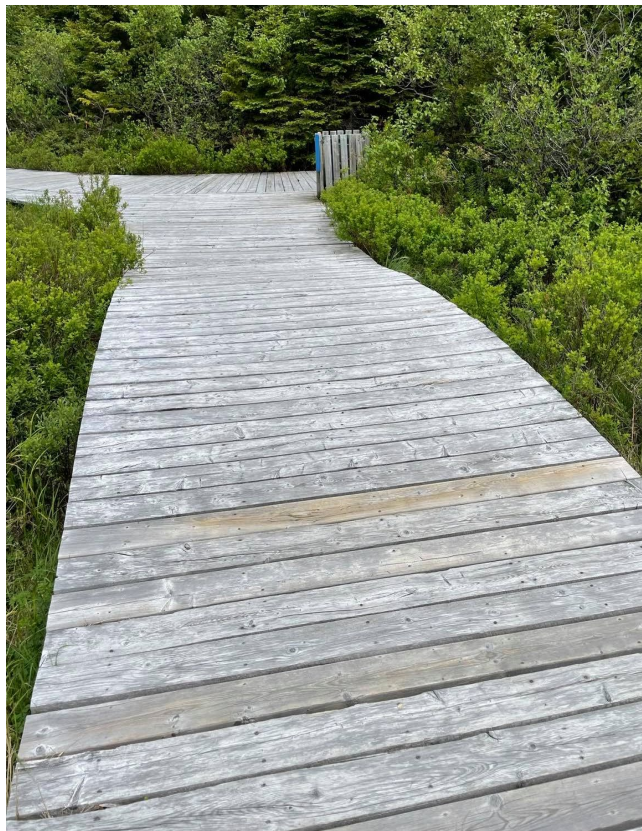
Figure 4: Unexpected bump in boardwalk  
Edge Protection not present

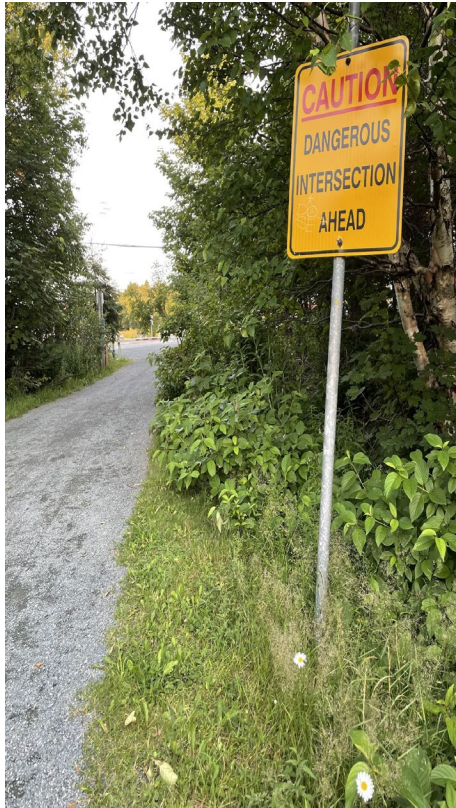
Figure 2: Commonwealth crossing unmarked & very dangerous  
Recommend going up to the intersection to cross

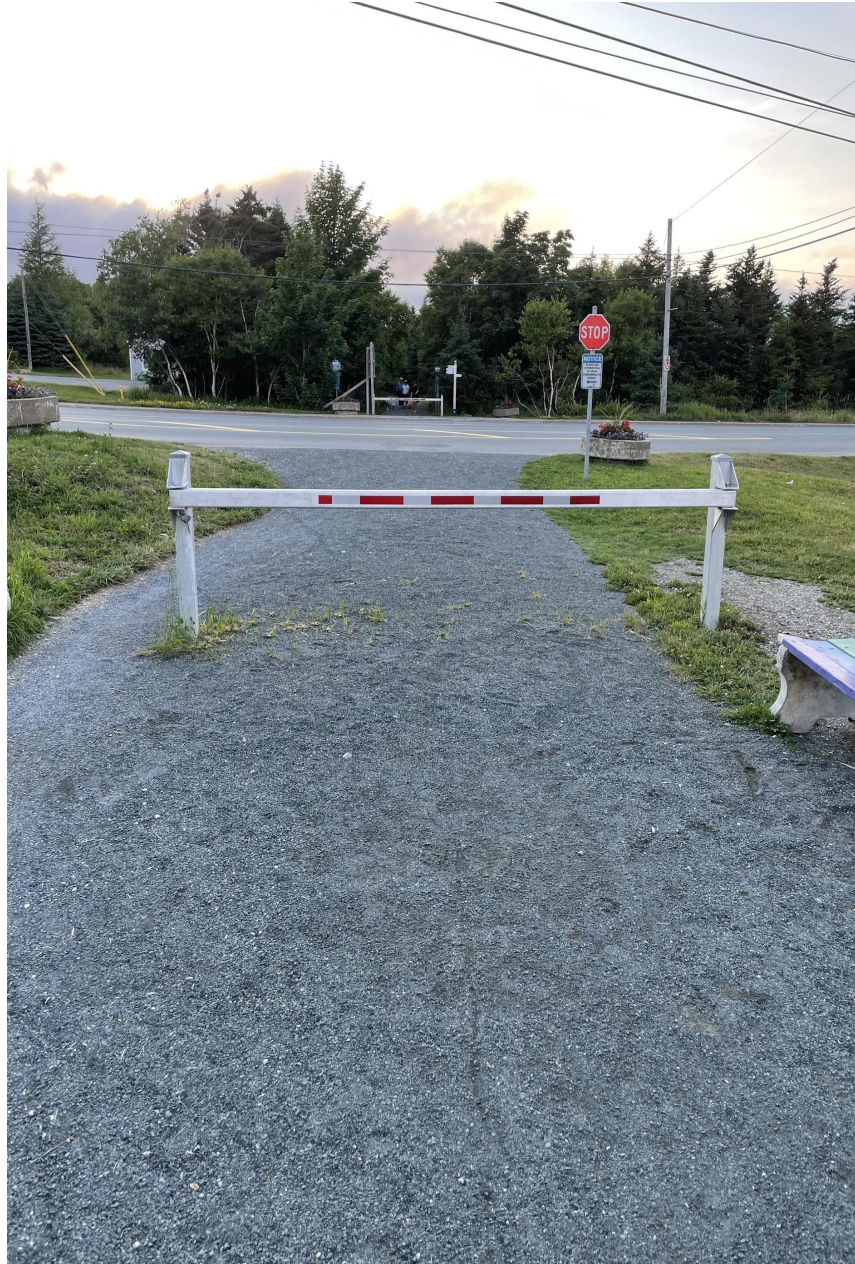
Figure 4: Barricaded entrance makes access difficult

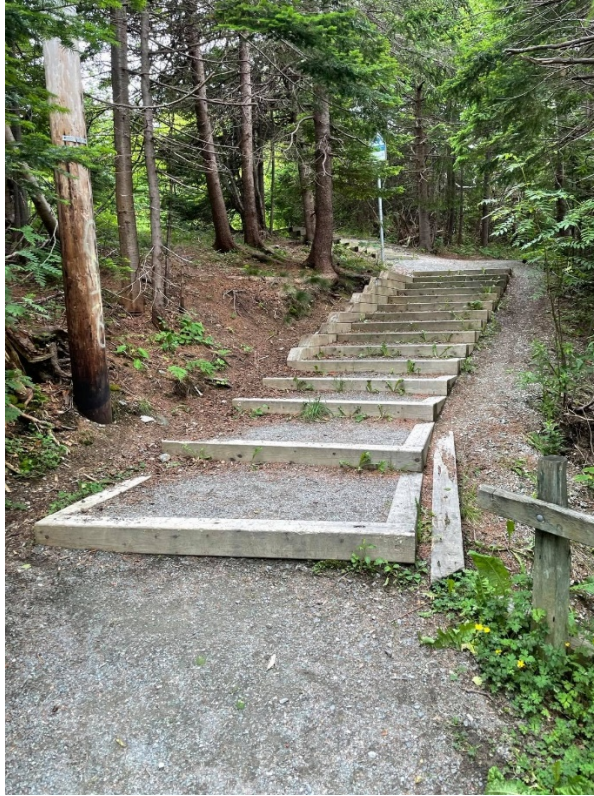
Figure 3: Wooden and gravel stairs with no rails

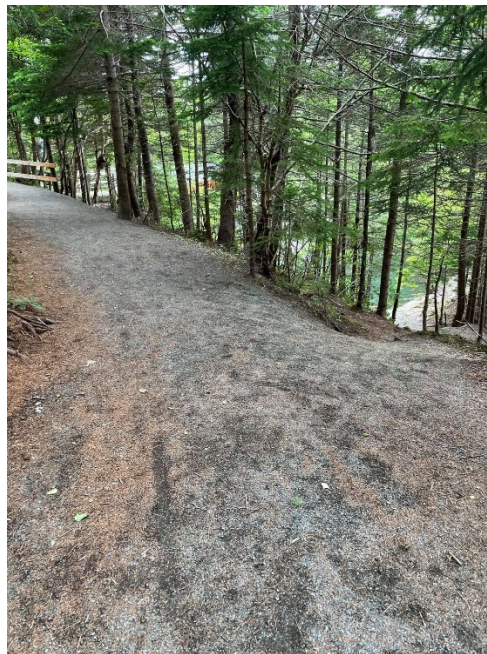
Figure 4: Trail runs along steep drop off without handrails present

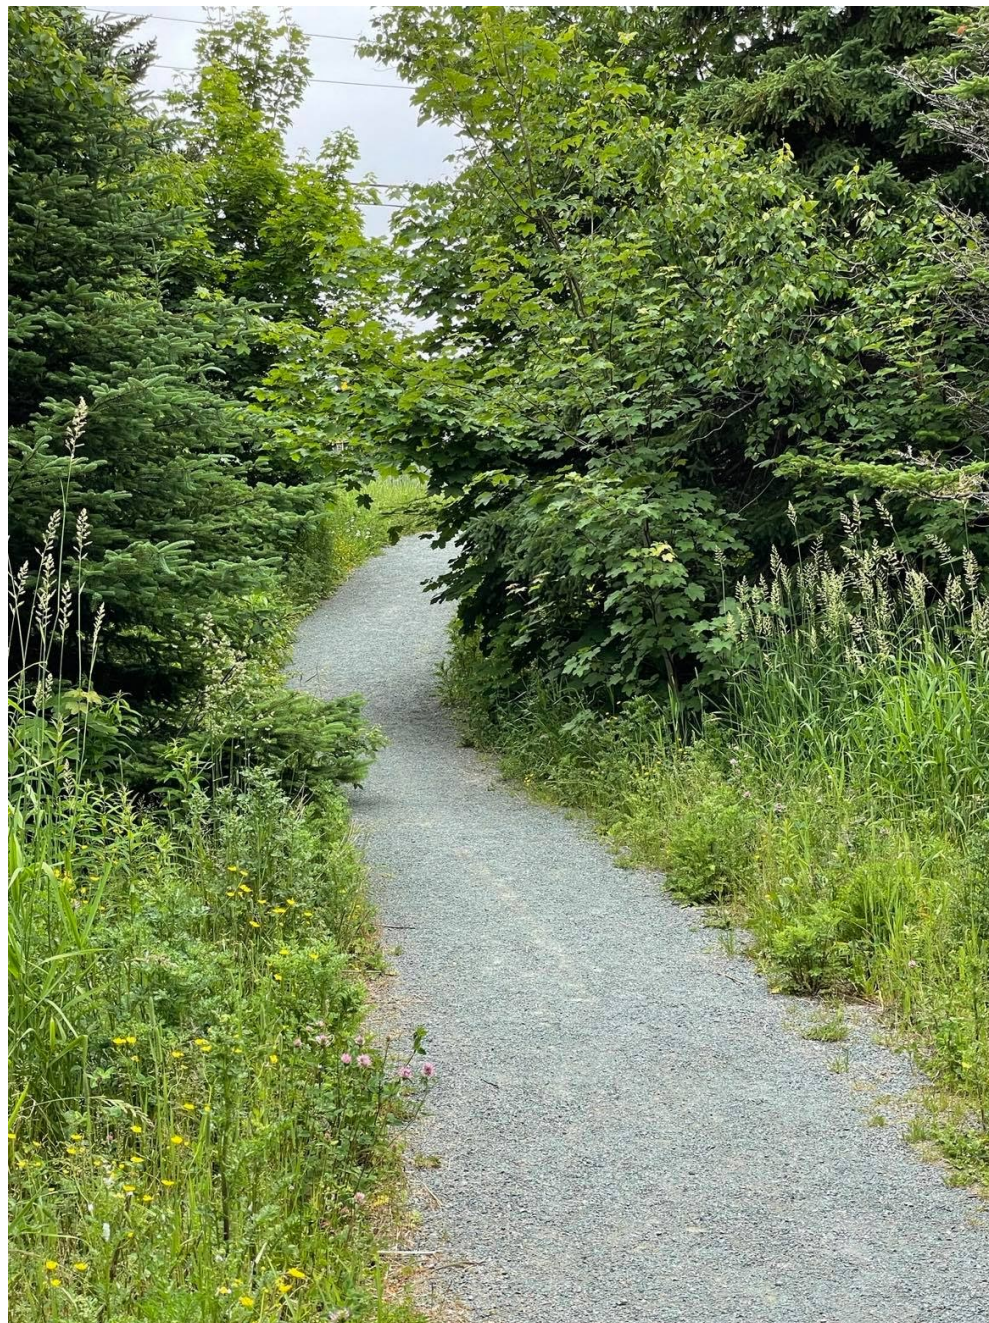
Figure 5: Places where overgrown trees impede trail width clearance
